PASSAIC RIVER BASIN
" HOKUS CREEK, BERGEN COUNTY
NEW JERSEY

SHADOW LAKE DAM

NJ 00232

PHASE 1 INSPECTION REPORT
NATIONAL DAM SAFETY PROGRAM

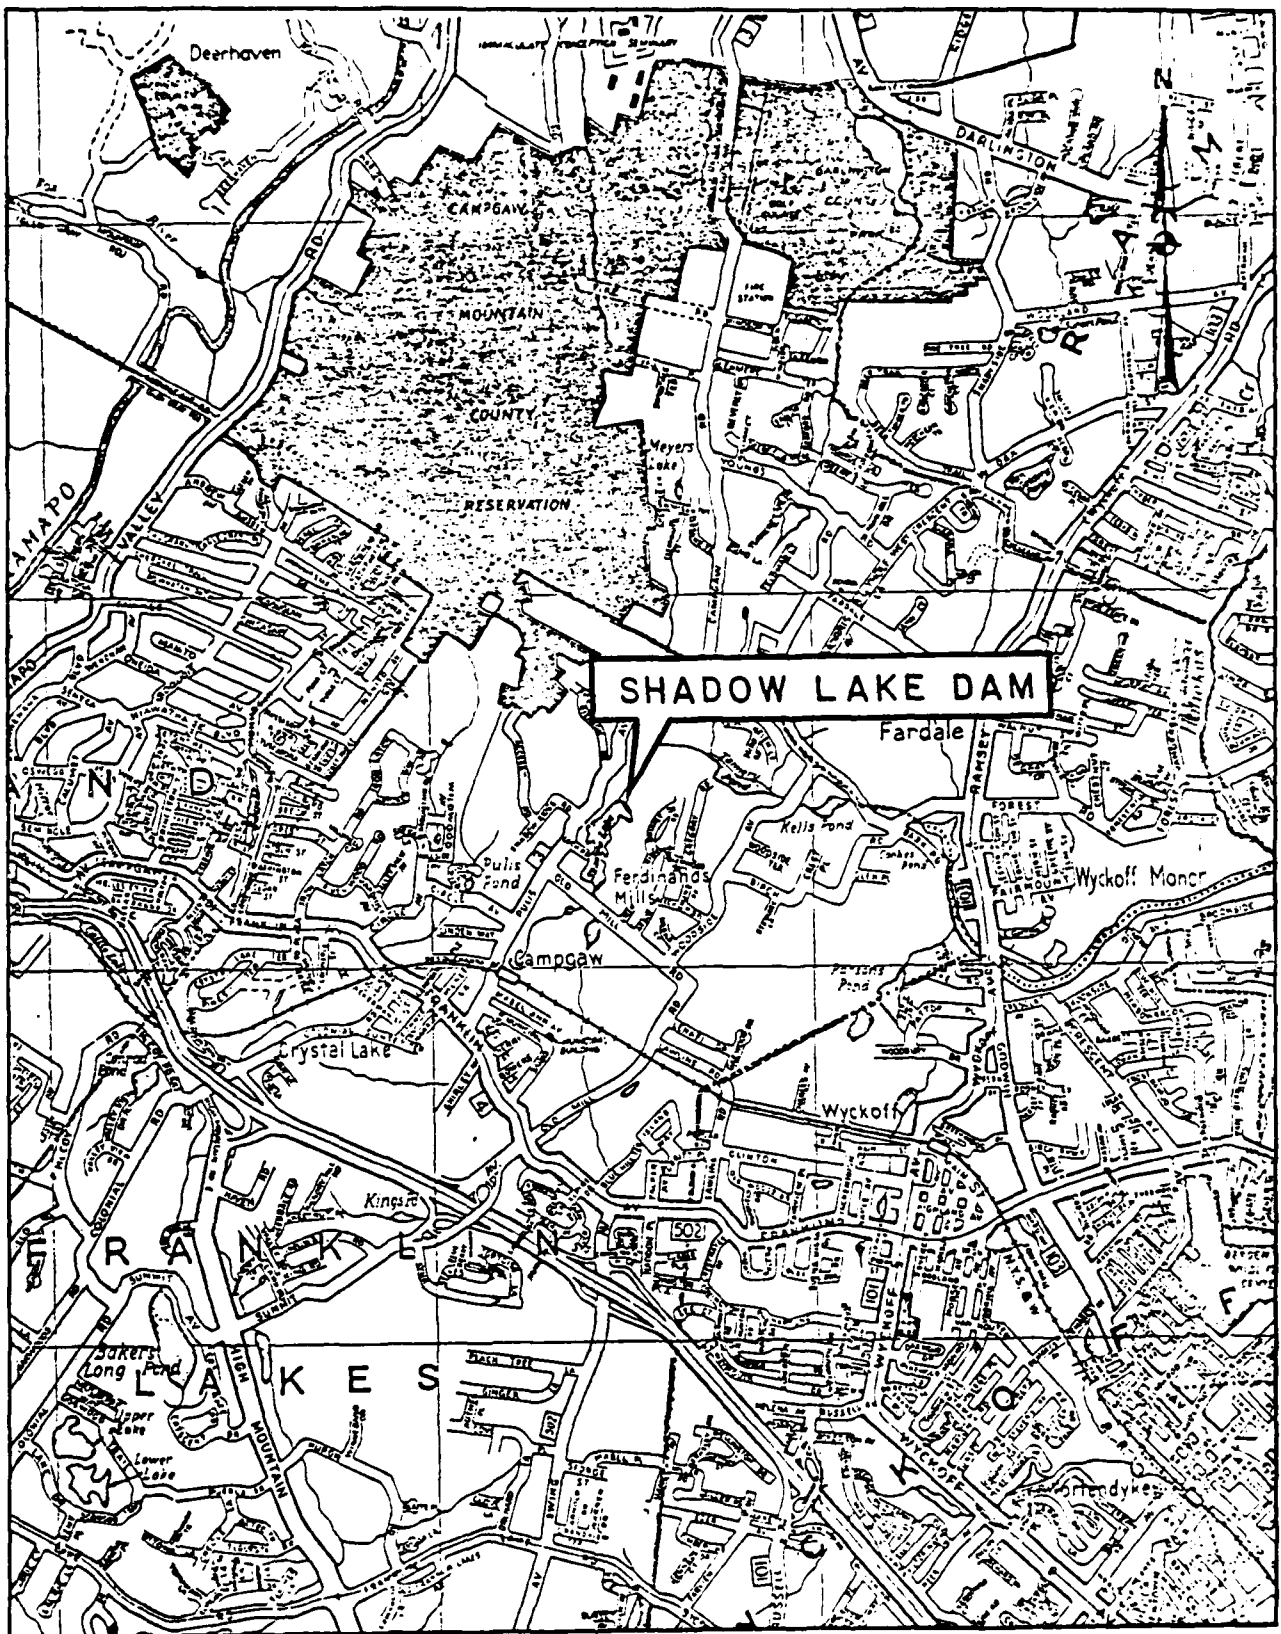
PLATE 1A

VICINITY MAP

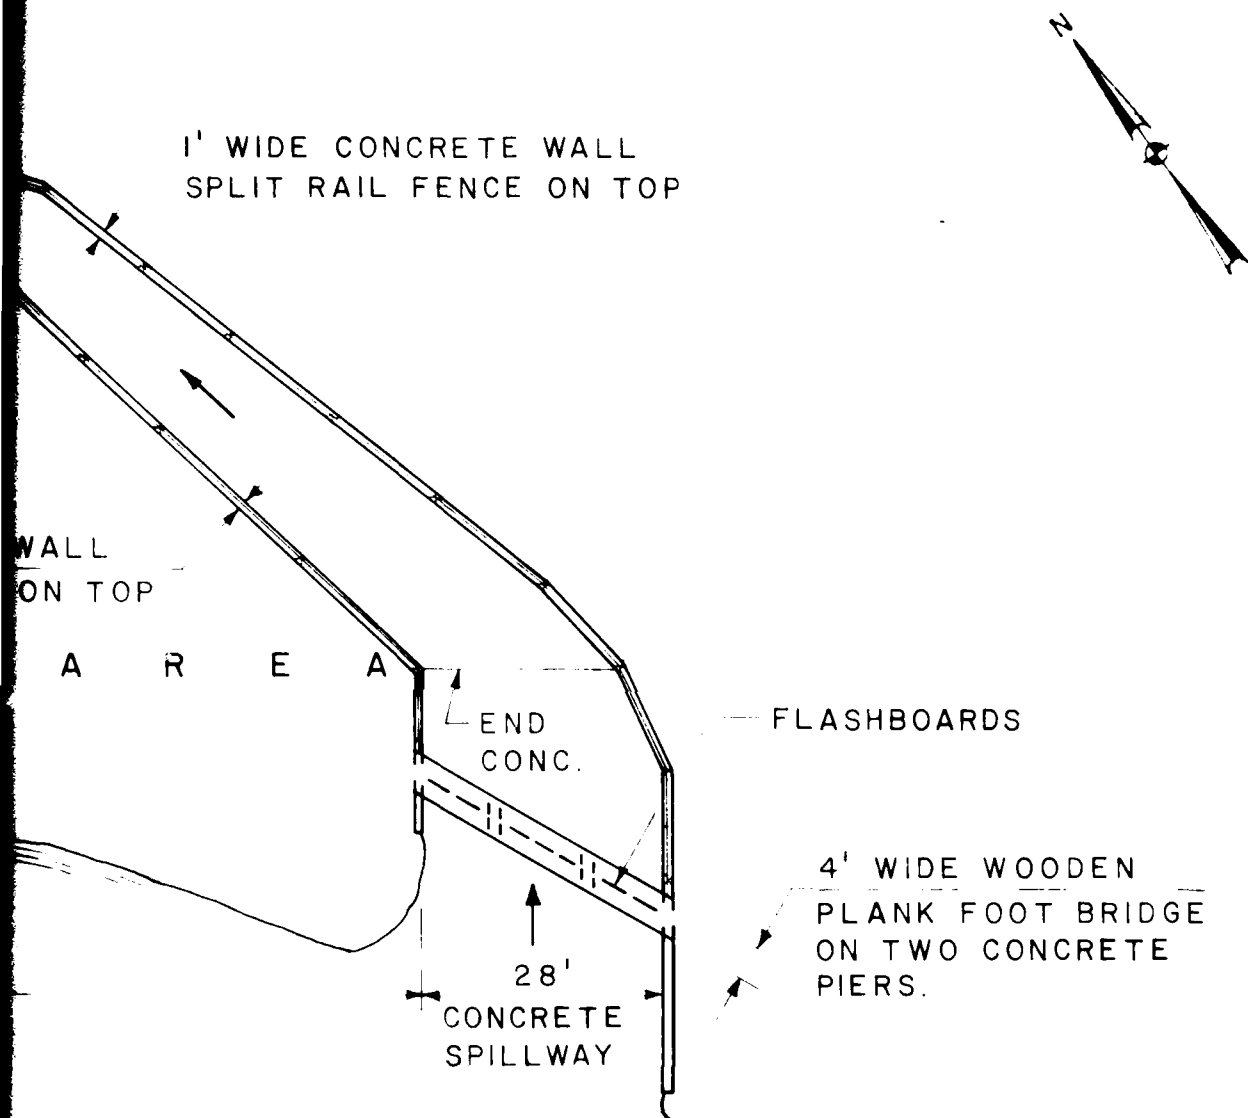
SHADOW LAKE DAM
BORO OF FRANKLIN LAKES, BERGEN COUNTY, N.J.

SKETCHES OF PLAN AND SECTIONS
PREPARED FROM FIELD NOTES TAKEN
DURING INSPECTION ON NOV. 27, 1979
